by Jeff Griffin, Senior Editor

Not Your Common Sliplining

Unusual Project Requires Creative Solutions

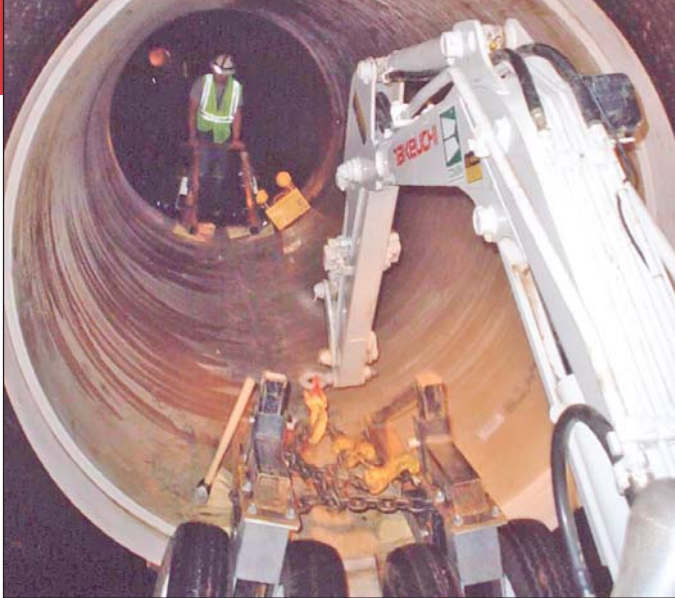
an inspection with ground penetrating radar (GPR) was made to locate any potential problems.

“GPR inspections were made every five feet making a loop around the pipe,” said Seal. “More grout was pumped into any voids that were located.”

Grouting was divided into four sections as pipe was installed with brick and mortar bulkheads constructed to separate the sections and hold the cellular grout which was pumped through two-inch threaded ports in the pipe located every 10 feet and alternating in a spiral from 12, 3, 6 and 9 o’clock.
