Rapid Cure Lining Offers Advantage Of Same Day Project Completion

A rapid-cure polyurethane lining system with a history of success in Europe has impressed owners of several water system rehabilitation projects in North America where it is being marketed by Alltech Solutions, Moncton, New Brunswick, Canada.

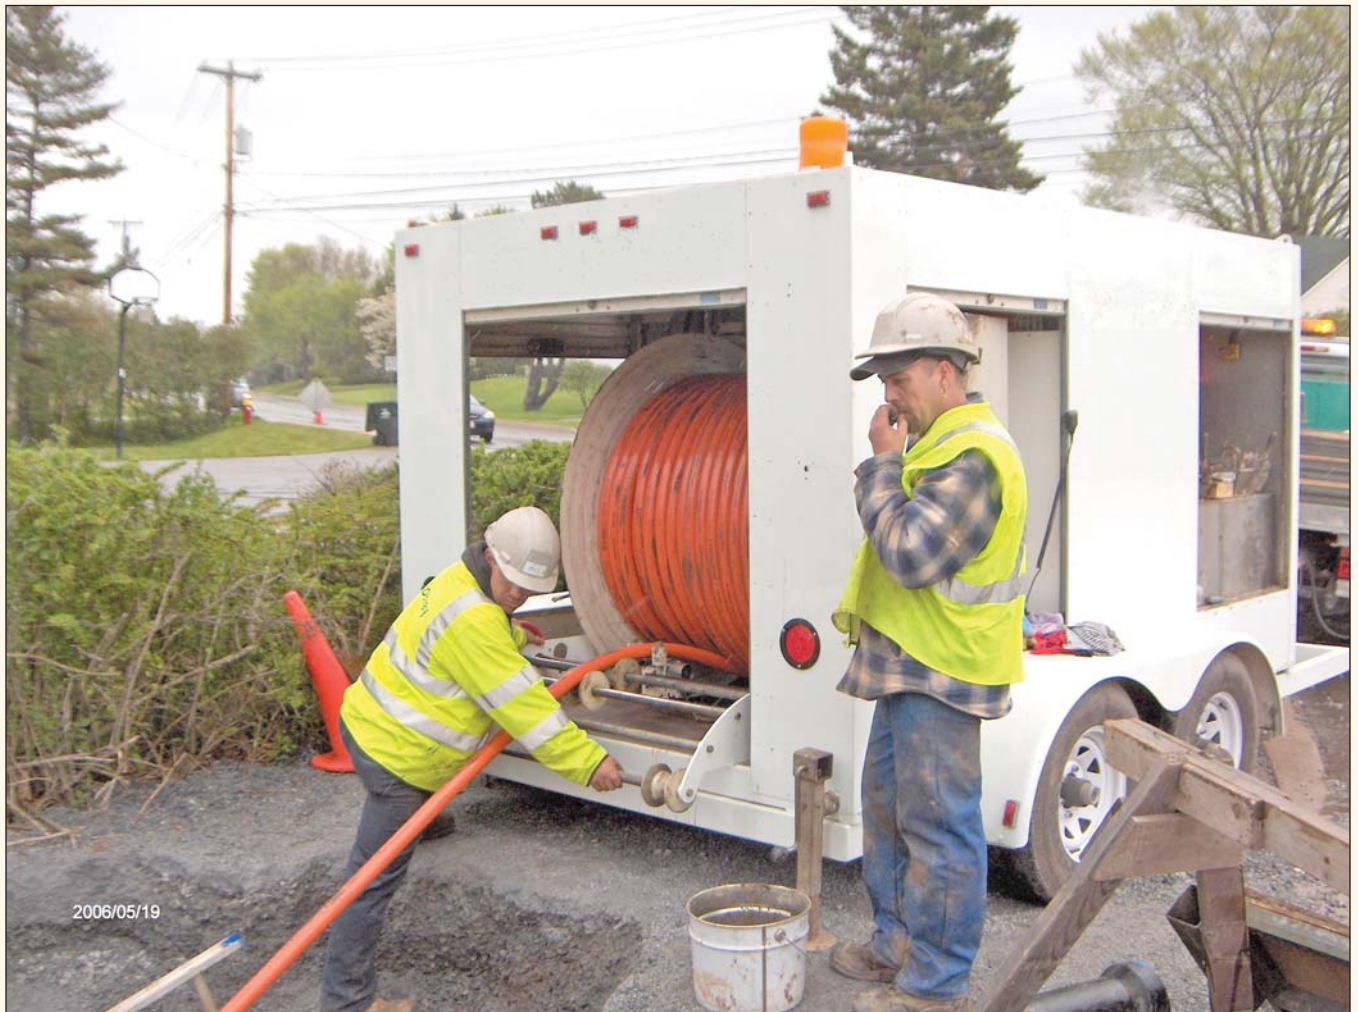
A second pit is dug, the umbilical cord of the lining equipment is inserted into the pipe, and the spraying application is begun.

"Application of the spray usually is completed in about one hour," says Horsman. "Within 10 minutes, curing is sufficient to permit a post-lining CCTV inspection to confirm proper application of the coating. After the inspection of the lined section of pipe, it is reconnected at one pit and the other is capped to restore unidirectional flow. By maintaining unidirectional flow, we have introduced an added safety check."
